5.0 Falls City, Texas, Disposal Site

5.1 Compliance Summary

5.3.1 Annual Inspection and Report

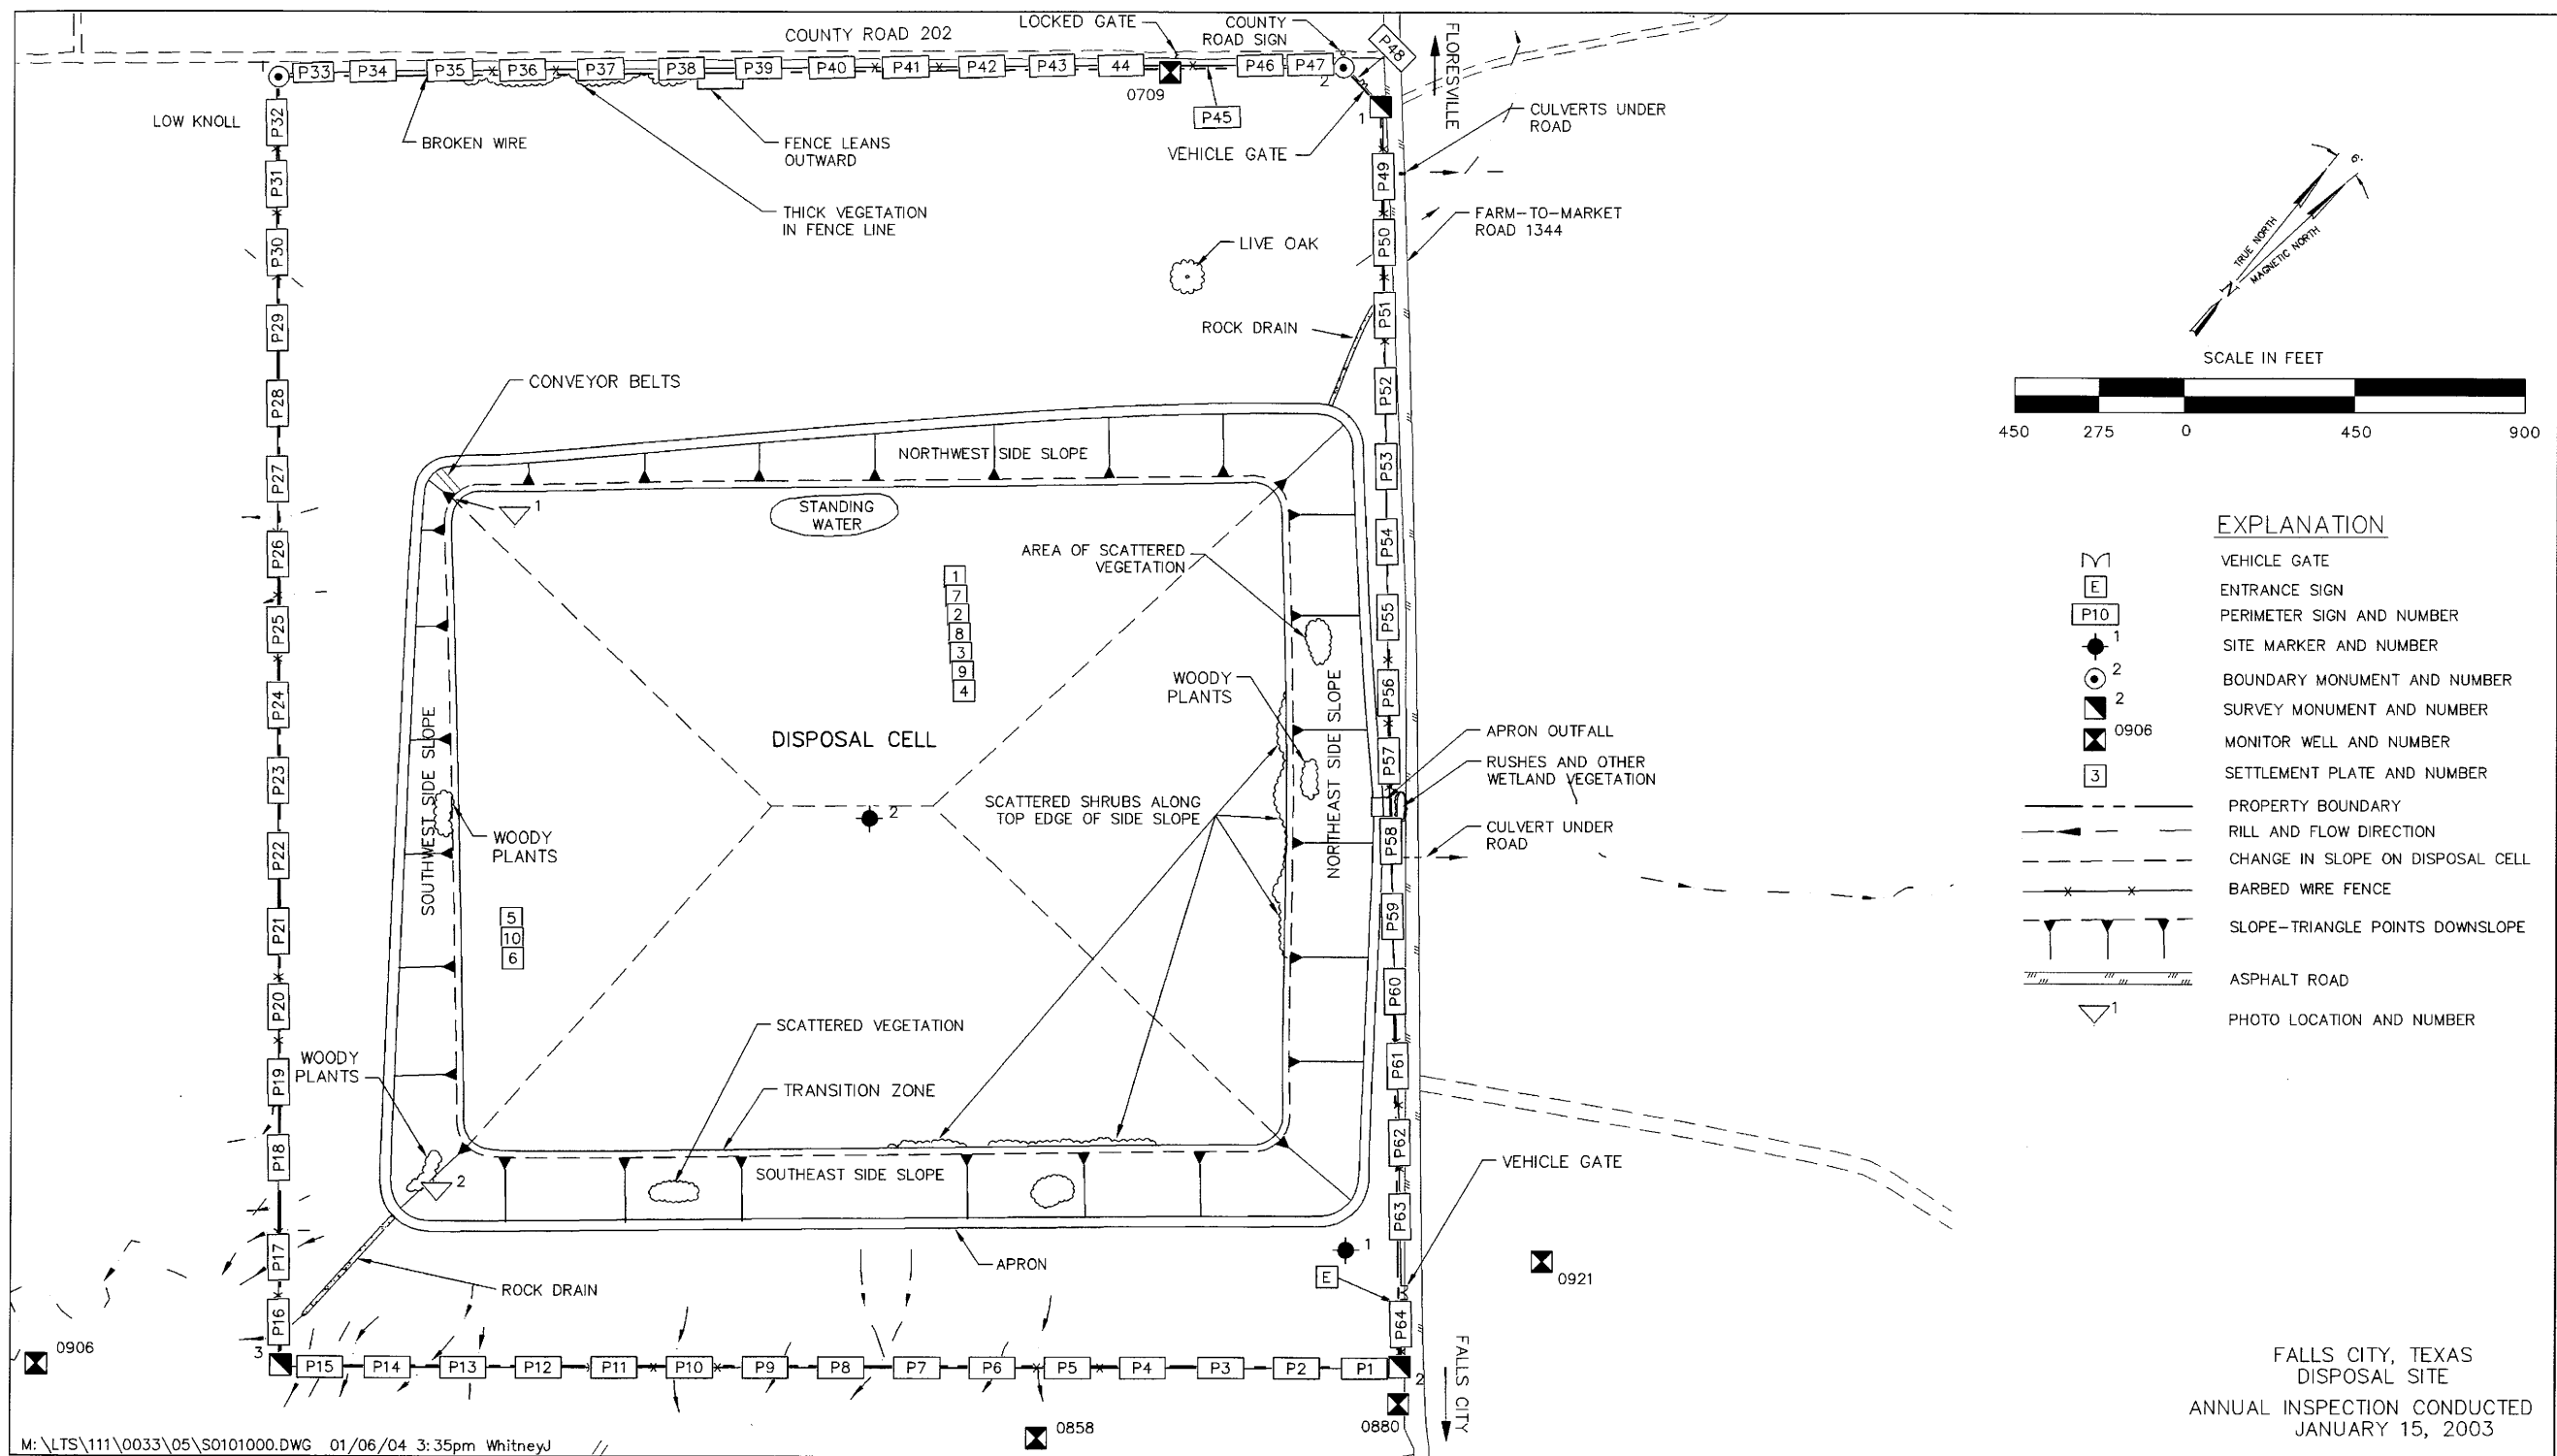
Figure 5-1. 2003 Annual Compliance Drawing for the Falls City, Texas, Disposal Site

The site, located east of Falls City, Texas, was inspected on January 15, 2003. Results of the inspection are described below. Features and photograph locations (PLs) mentioned in this report are shown on Figure 5-1. Numbers in the left margin of this report refer to items summarized in the Executive Summary table.

The side slopes are covered with riprap and were in excellent condition. As noted during previous inspections, small amounts of fractured riprap were observed along the side slopes. The fractured riprap apparently is an artifact of quarrying and placement of the rock and does not appear to be degrading. However, DOE continues to visually monitor the riprap for indications of rock degradation.

Two tracks of steel-belted rubber conveyor belt material were placed on the west corner of the disposal cell by the hay farmer (PL-1). The conveyor belt material appears to keep the rocks from being overturned as farm equipment is driven up and down the side slope, and does not adversely affect the function of the disposal cell. The material may be left in place as long as it does not fragment into smaller pieces and become distributed as litter.

Most vegetation on the side slopes was dead due to herbicide treatment; however, a few woody plant species were found growing along the side slopes (PL-2). Greasewood and similar species are concerns because they are deep-rooted. Vegetation control will continue on the side slopes.

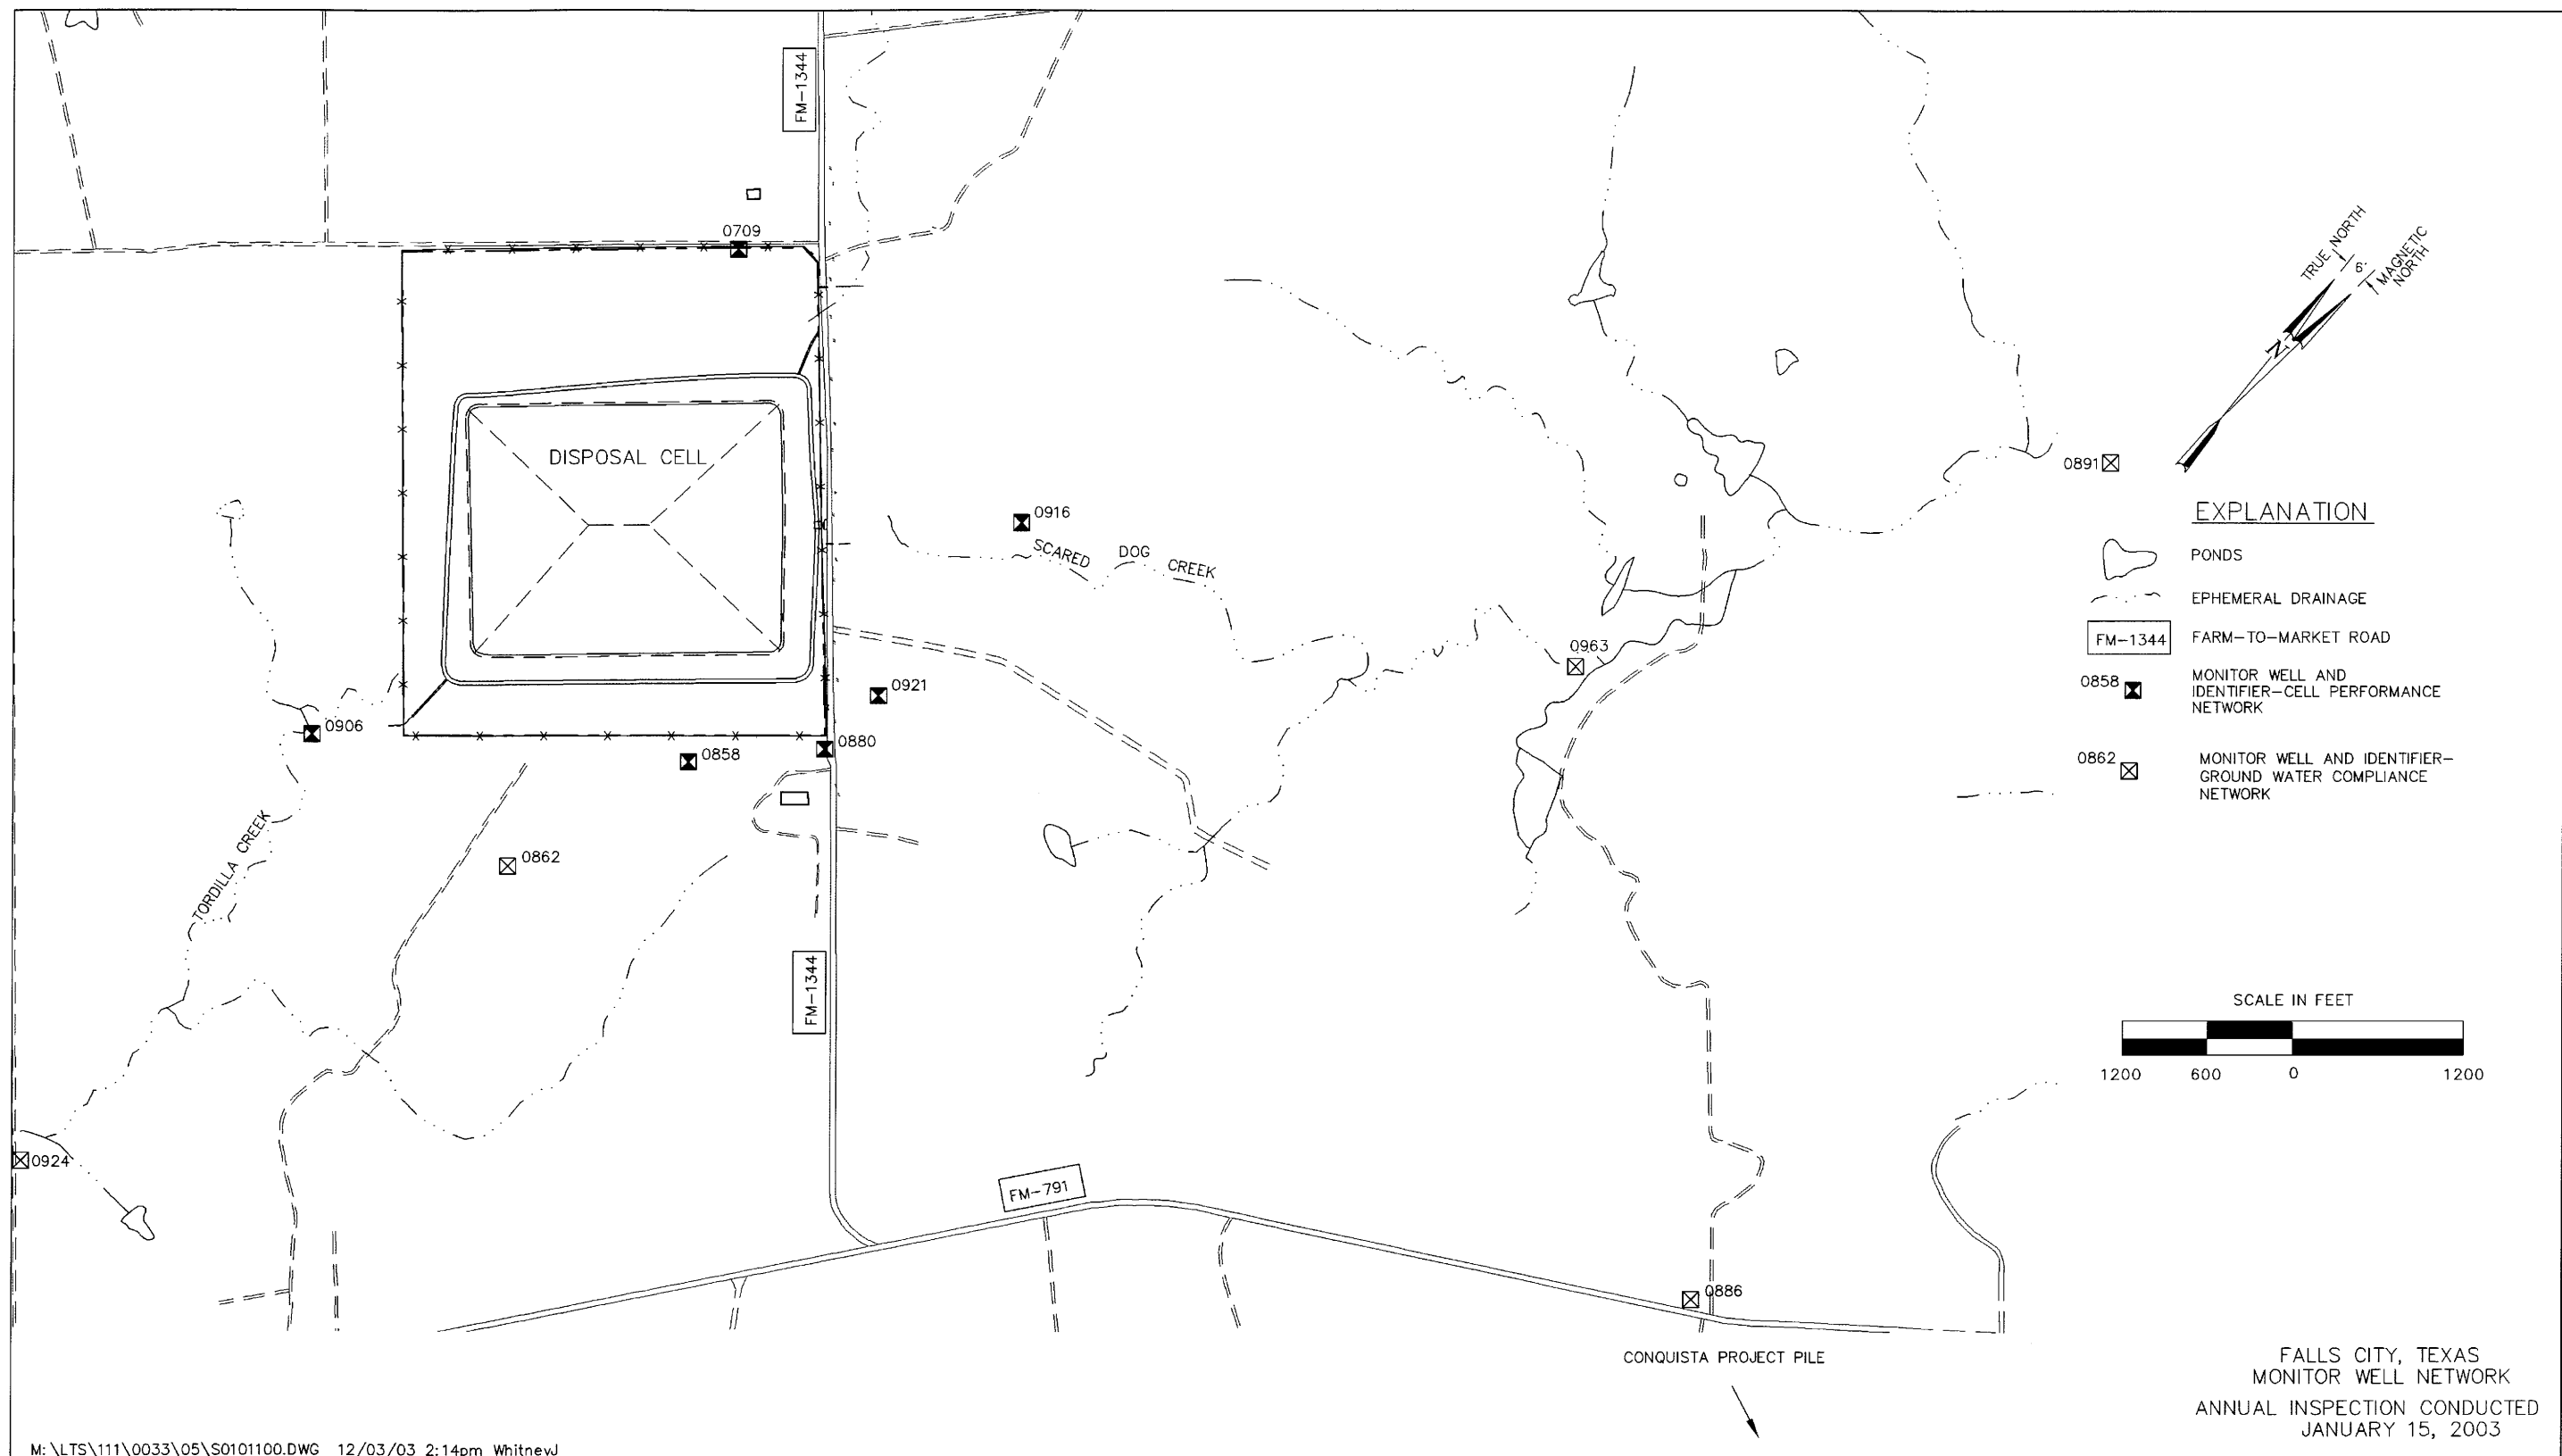
Figure 5-2. Monitor Well Network at the Falls City, Texas, Disposal Site

The disposal cell performance monitoring network consists of five monitor wells (MW-0709, 0858, 0880, 0906, and 0921) that are sampled semiannually as specified in the Long-Term Surveillance Plan. The ground water compliance monitoring network consists of five monitor wells (MW-0862, 0886, 0891, 0924, and 0963) that are sampled annually as specified in the Ground Water Compliance Action Plan. Ground water samples from the ten monitor wells are analyzed for 33 constituents, including ten which have maximum concentration limits specified in Table 1 to Subpart A of 40 CFR 192. The Long-Term Surveillance Plan identifies pH levels in ground water as the indicator for disposal cell performance on the basis of tailings pore-fluid chemistry. The monitor well network is shown on Figure 5-2.

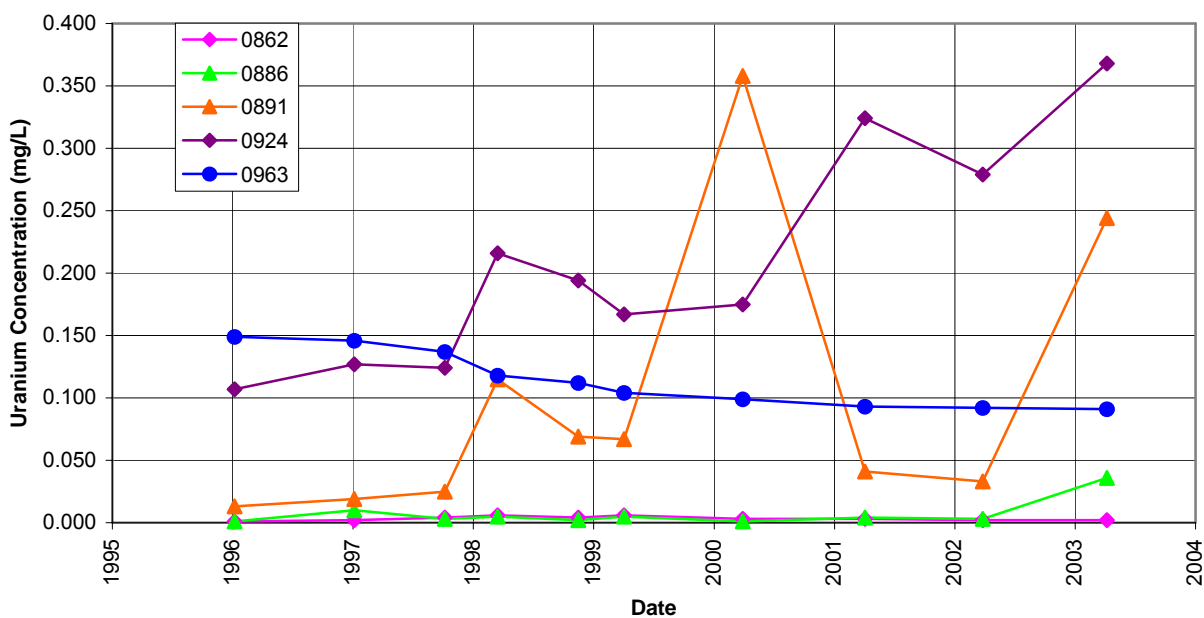
Figure 5-6. Uranium in Ground Water at Compliance Monitoring Locations at the Falls City, Texas, Disposal Site

Uranium concentrations in ground water in the vicinity of the disposal cell are consistent with previous results with the exception of monitor well MW-0880, where concentrations continue to increase (Figure 5-5). This increase may be an indication of seepage from the disposal cell, as expected; there is no risk however, because ground water is not used in the area. Uranium in ground water in the compliance monitoring network has varied substantially in two wells (MW-0891 and MW-0924) since 1997 and exceeded the maximum concentration limit of 0.044 mg/L in three wells (MW-0891, 0924, and 0963) in 2003 (Figure 5-6). Concentrations of other analytes in ground water are similar to previous results.
